Project Number: 5-28198.00

# Analysis and commentary on fatal and serious level crossings crashes 2010 - 2020

Date: 16 August 2021

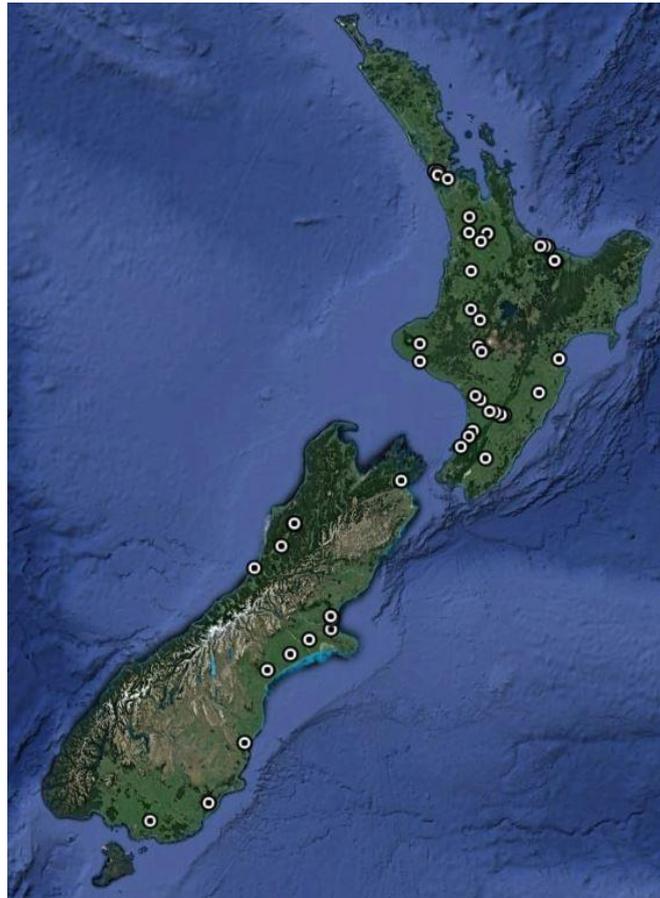
*Figure 4-1: Location map of fatal and serious level crossing crashes 2010-21*

As can be seen by the map (Figure 4-1) the crashes are well scattered throughout the country. Few crossings can be described as multiple crash sites. There is a definite random element to whether a motorist at a particular crossing arrives at the same time as a train and does not perceive its presence. The crashes at a crossing will also be influenced by the traffic flow, both on the road and the rail line, as a road vehicle and a rail vehicle need to meet in order for a crash to occur. Of the 50 crashes, 17 were in areas with a 50 km/hr or lower posted speed limit and 33 were in areas with a posted speed limit greater than 50 km/hr. Several were on private roads or driveways crossing the rail corridor.

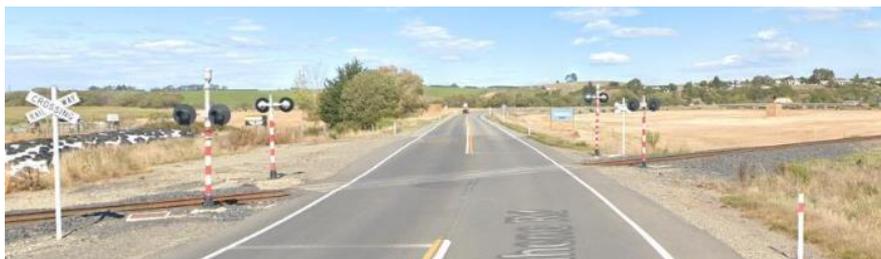
Figure 6-2: Alma Mahino Rd crossing

It is noticeable that there are flashing lights and bells/crossbuck controlled crossings on 100km./hr roads around the country which are generally traversed by traffic at high speed and have neither Stop nor Give Way signs.

An example is a crossing on Alma Mahino Rd in Otago. Illustrated in Figure 6-2, Figure 6-3, and Figure 6-4.

It has no Give Way or Stop signs. Upstream it has standard sized train signs (Figure 6-3) and on the other side a curve/ railway line sign in addition to the train sign (Figure 6-4). The indication of a railway on the sign is very small.

Perhaps more conspicuous signage could be considered along with a speed limit reduction in the vicinity of the crossing. This could possibly mean around 250 m of 70 km/hr limit either side of the crossing, and/or a dynamic speed adjustment if a train is detected near the level crossing. Speed compliance could also be observed to see if any intervention implemented is having an impact. Advance warning signs are generally of standard size but larger sizes are optional under the relevant Waka Kotahi guidance (Waka Kotahi, 2012).

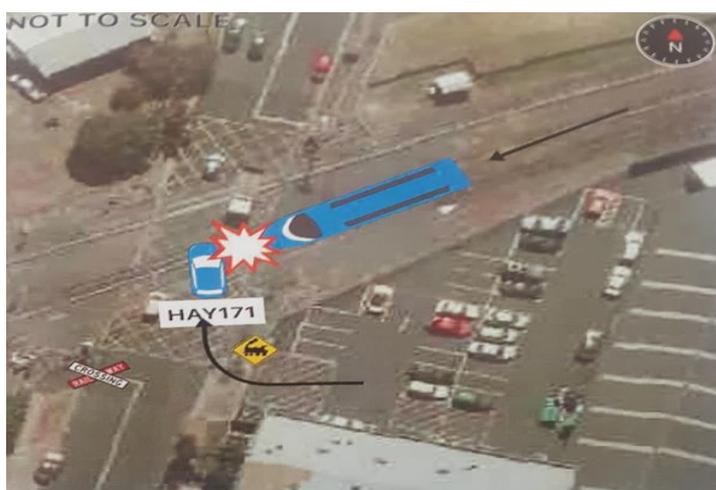
Figure 9-1: Police officer's diagram of Morningside Drive crash

The vehicle came out of a carpark on the right hand side of the road relative to the approach to the crossing on the western side of the tracks. The carpark exit was forward of the crossbuck signage and flashing lights and pretty much level with the barrier for the traffic on the left side of the street. It is a situation where vehicles could attempt to sneak out of the car park and over the rail line while the bells are ringing and the barriers down because the left hand side of the road barrier does not totally block their path. This vehicle did that and hit the barrier and also the train. An illustration of the crash can be seen in Figure 9-1.

This is a potentially dangerous situation with the carpark exit in line with the barrier for the left hand side of the street. The manoeuvre could be discouraged by extending the fencing out to the edge of the cross hatched area, near where the curb ends before the properly formed curb crossing to the parking area. The manoeuvre is encouraged by the presence of informal ramps within the crosshatched area. This risk has been mitigated by traffic management within the adjacent property. This access is now defined as 'Entry Only'. However, there has been no extension of the fencing to provide a physical barrier.

- Is the warning time provided by the bells always sufficient at bell controlled crossings?
- Are there ways by which traffic can bypass the barriers at some barrier controlled crossings e.g. the carpark exit involved in the Morningside Drive crash.

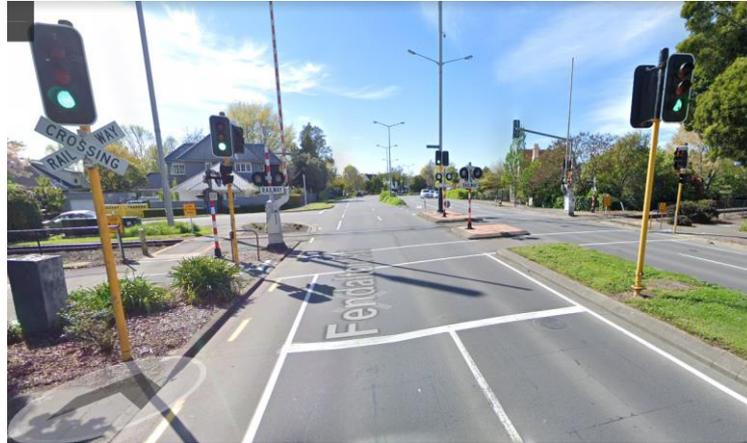
Figure 9-2: Site photo of Fendalton cycle crash

A cyclist on the footpath saw the train when it was part way through the intersection and was hit by the train. There were no barriers for people/vehicles using the footpath. There were barriers for road traffic. Media reports after the Coroner's findings were released stated that there was no evidence of use of headphones or other technology that would have distracted the victim. The layout of the site can be seen in Figure 9-2

- Should barrier controls be provided for cyclists and pedestrians on footpaths/shared paths where they are provided for vehicles using the roadway?
- Could delineation (e.g. optimised highly visible road marking indicating a crossing is ahead) be used as another way to inform road users that they are approaching a non-barriered highspeed road level crossing?

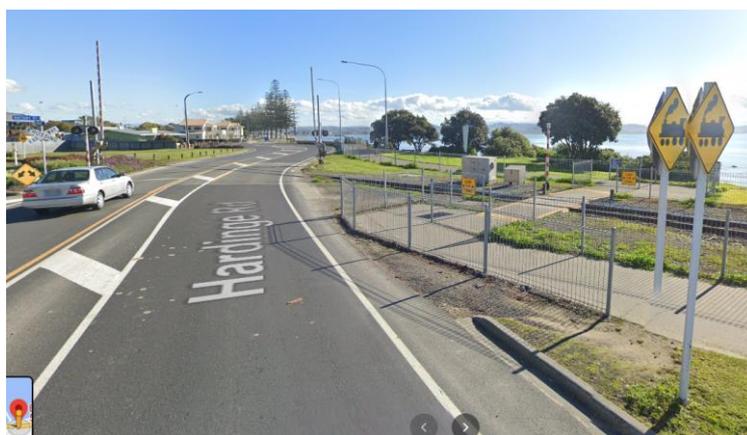
Figure 9-3: Site photo of Napier cycle crash

The barriers were down, and the warning bells were sounding. The cyclist approached the railway crossing, as the train approached it is sounding its horn twice. When the cyclist was approximately 5 m away from the train, he attempted to cycle over the railway tracks. The cyclist was immediately struck by the front of the train. The crash occurred on a cycle pedestrian path adjacent to the road level crossing which has barriers. There are no bells or security fencing on this crossing and one single symbolic train sign. A Kiwirail investigation recommended a review of the pedestrian crossing at the facility. The site of this crash is shown in Figure 9-3.

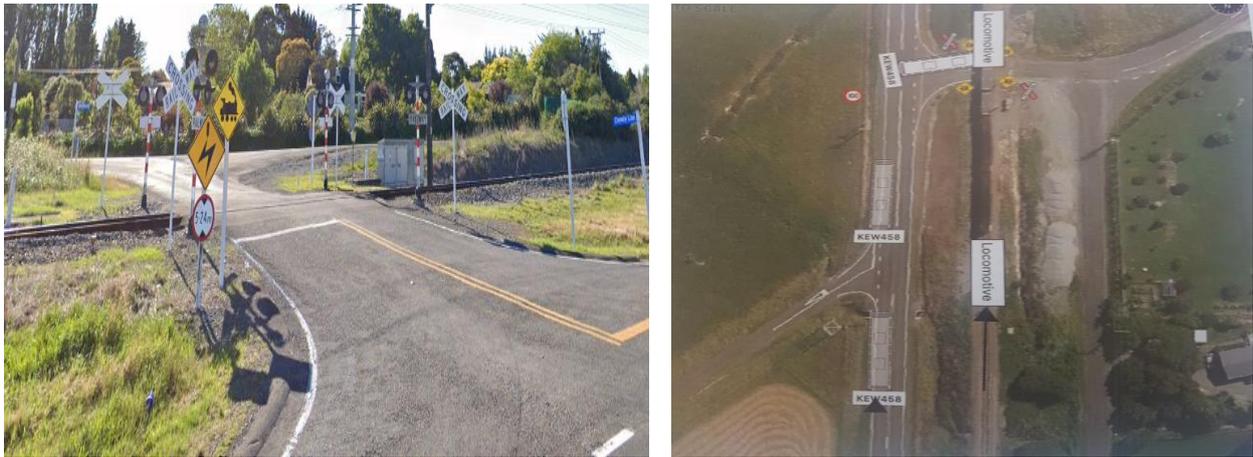
Figure 9-4: Google street view of crash site (left) and Police Officer depiction of the crash (right)

The bus collided with a north bound locomotive which was not hauling any wagons or carriages and was not running at a time when the driver would have been expecting a train. The bus driver was an experienced traverser of the route and had turned right perpendicularly towards the crossing from railway road. All the bells etc were working and there was a railway warning sign 300 m down railway road prior to the intersection. This crash may have been related to the unexpected nature of the locomotive at that time of day to the regular driver of the bus route. Figure 9-4 depicts to the left a Google street view of the crash site and to the right the Police Officer's depiction of the crash.
